# CONCRETE CANVAS DITCH LINING

Case Study

Project Name	CDOT I-25 South Gap Side Drainage
Location	Larkspur, Colorado
Date of Installation	July 2022
Contractor   Owner	Kraemer North America   Colorado Department of Transportation
Salesperson	Ryan Anderson
Application/Solutions	Concrete Canvas used to provide erosion control to flow drainage located on the side of a highway.

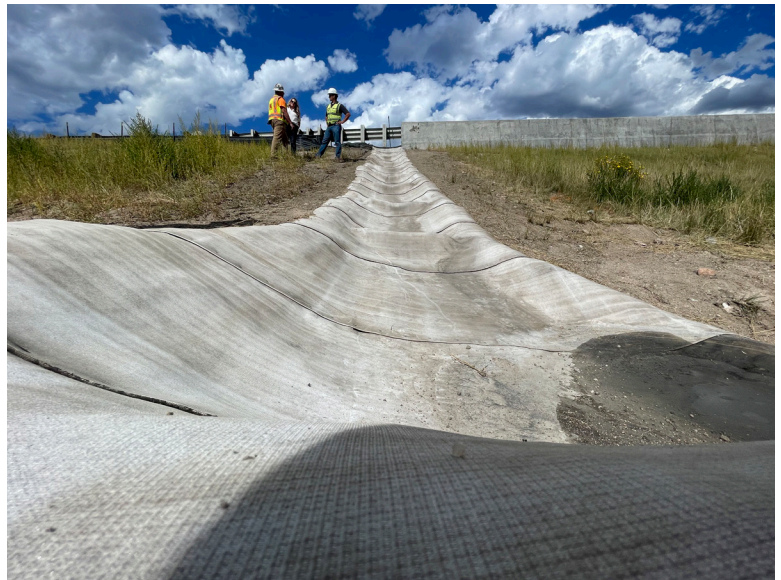
Completed Installation

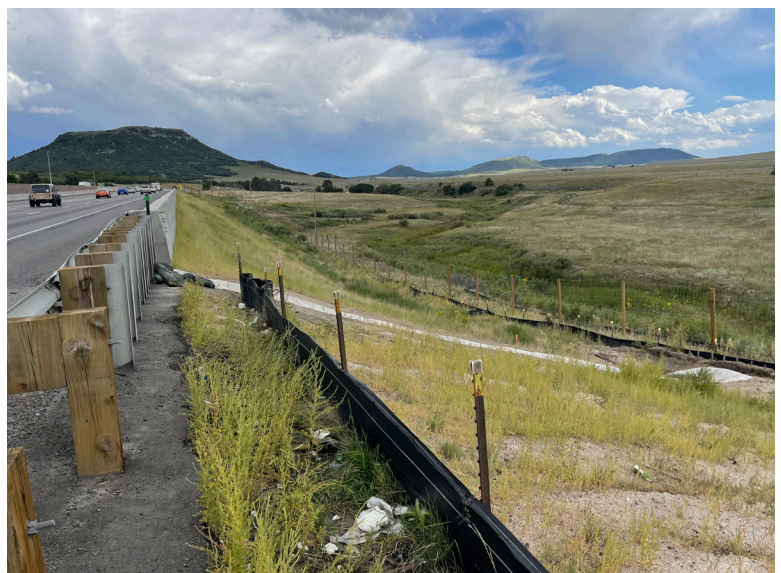
Location of Ditch Next to I-25 Highway

During periods of rainfall, rainwater runoff from the I-25 highway was causing the slope to erode. Flow drains that were originally designed to discharge rainwater runoff from the highway and down the slope were being eroded, creating costly maintenance repairs. CDOT needed a long-term solution to mitigate the issues.

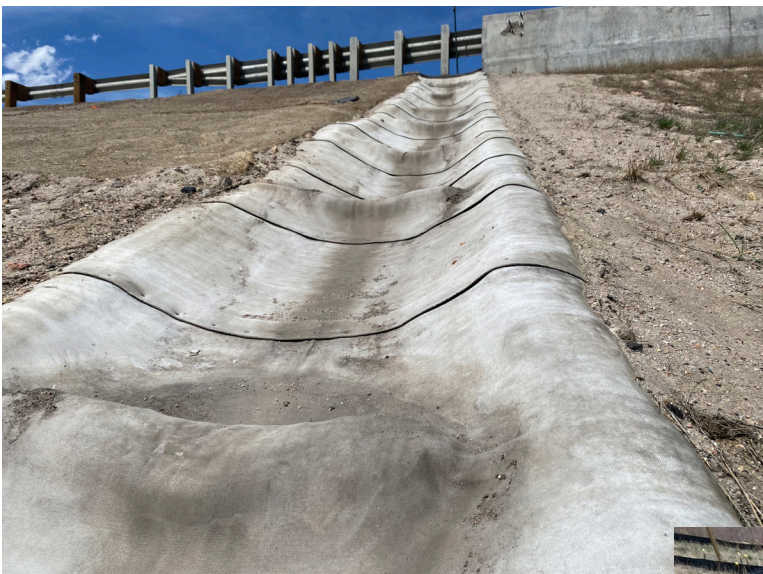
Concrete Canvas Laid Transversely Across the Channel

Batched Rolls of Concrete Canvas were brought on-site and laid by hand transversely across the ditch and the installed check dams. The material was then secured within anchor trenches using anchor pegs and later backfilled with excavated substrate. Each layer was overlapped by 4" in the directional flow of water. Stainless steel screws set at 4" spacings and 2" away from the overlapping edge were used to secure the CC material down. A sealant was used between layers, providing waterproof protection. After securing the Concrete Canvas material, it was hydrated using a small water tank and hose.

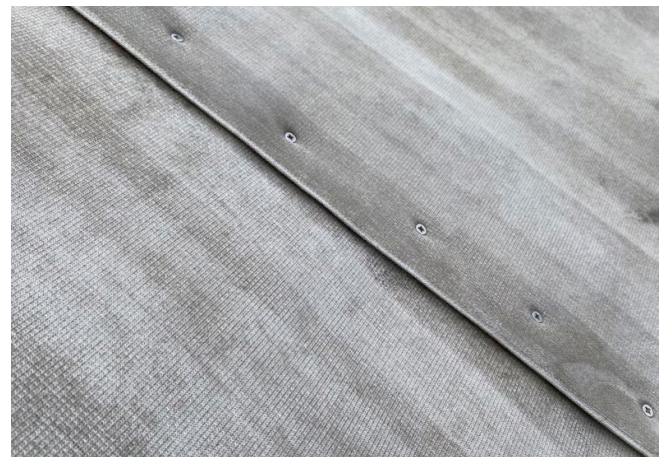
Overlapped CC Layers Secured Using Stainless Steel Screws

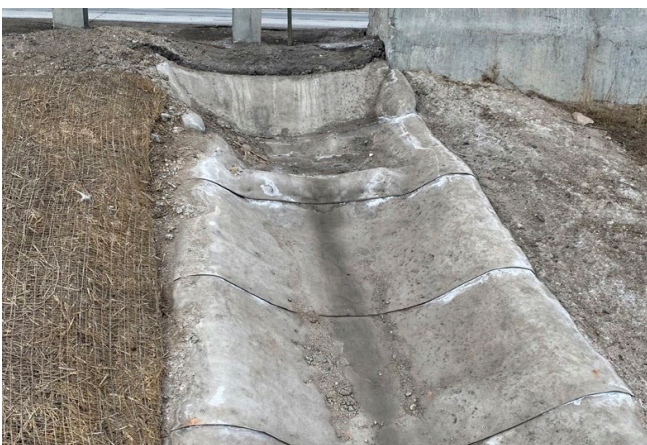
Concrete Canvas Secured with Anchor Trenches

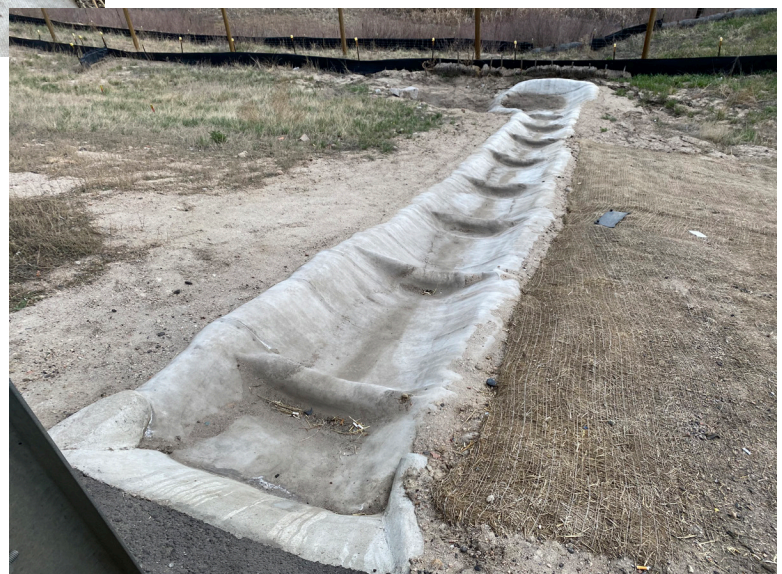
Check Dams & Dissipation Pond Covered in Concrete Canvas

Prior to the Concrete Canvas installation, vegetation and protrusions were removed, and the channel was regraded to create a solid and uniform surface. Anchor trenches were also excavated at the crests of the drainage ditch. To slow the flow of water coming from the highway, bags filled with aggregate were placed every 5' to create check dams, and a small dissipation pond was installed at the end of the drainage ditch.

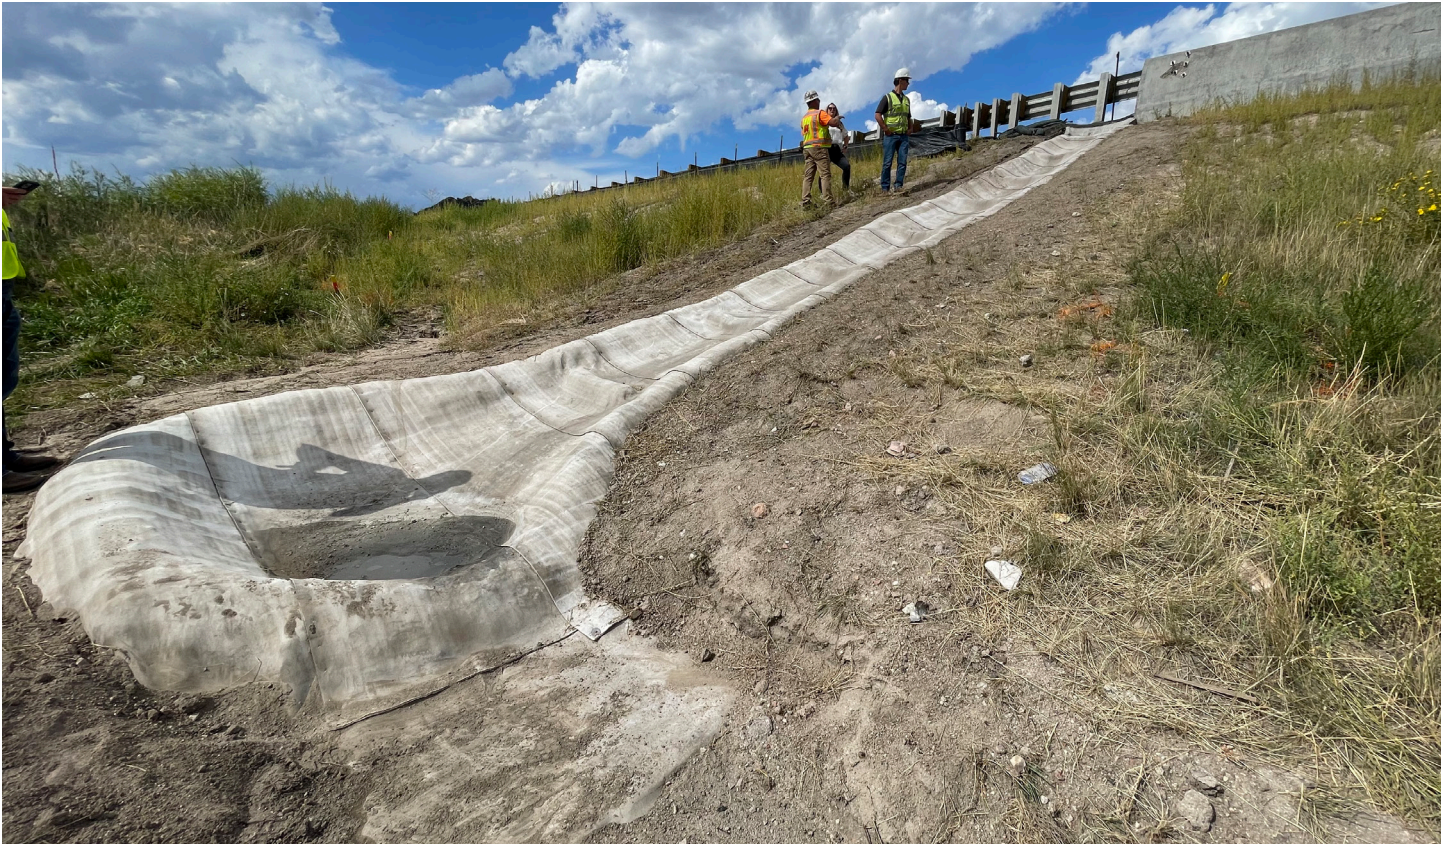
Completed Installation

A total of 600ft<sup>2</sup> of Concrete Canvas was installed during an 8-hour shift by a team of six. The owner and contractor were impressed with both the speed and ease with which CC was installed and were satisfied with the overall results of the project. Because of the results of this project, Concrete Canvas has since been installed at several other projects carried out by CDOT.
